Manhole Inspection Summary

Manhole # S23I1_007MH

Insp Date: **7/23/08 11:36 AM**

Location Address: **2737 Rittenhouse Rd**

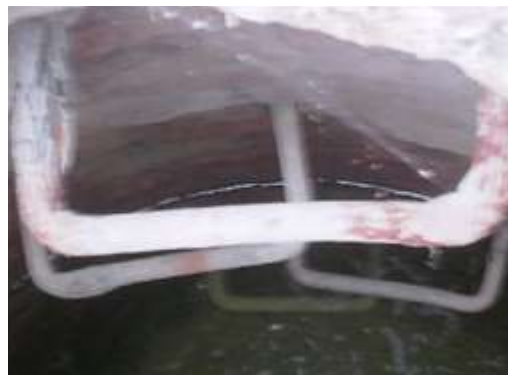
Defect 2

Steps Count: **4** Missing: **0** ☒ **Corroded**

corroded rung

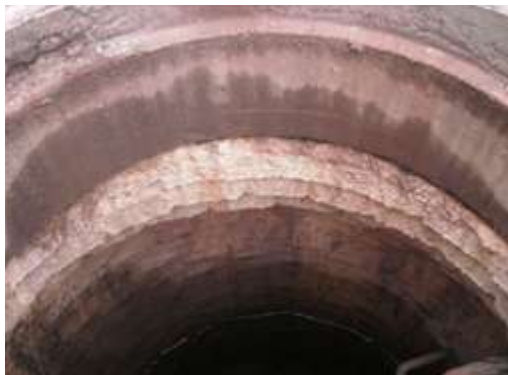
Defect 1

Frame Offset: **0** (in.) Condition: ☐ Sound ☐ Cracked ☒ **Leaks**

Infiltration: ☐ None ☒ **Joint** ☐ Cracks ☐ Mortar ☐ Roots ☐ Wall

lid- frame infiltration

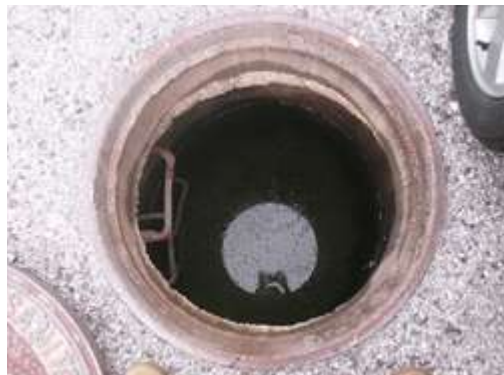
Defect 3

Surcharge ☒ **Evidence Of Surcharge** Depth: **2.5** (ft.) ☒ **Active Surcharge Present**

Surcharge Active Evidence

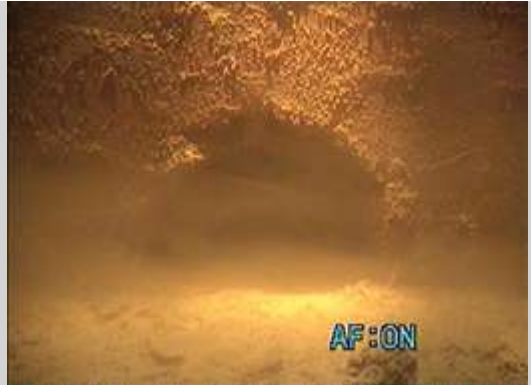
12 O'Clock Outflow

photo taken underwater

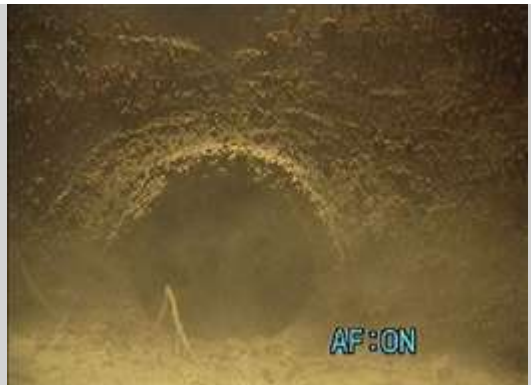
6 O'Clock Inflow

photo taken underwater
